# Manhole Inspection Summary

## Manhole # S17AA1012MH

**Location** Address: **GREENSPRING AVE**

Cross Street: **DRUID PARK DR**

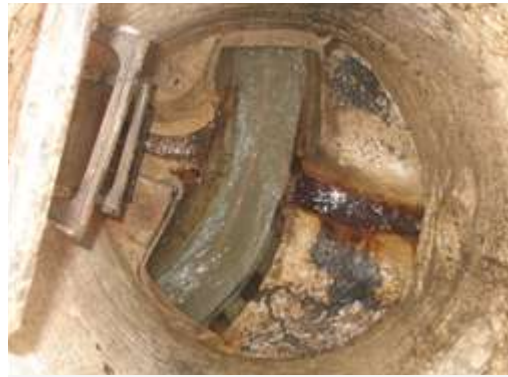
Top View

☒ **Debris** (not Condition related)

Bench debris.

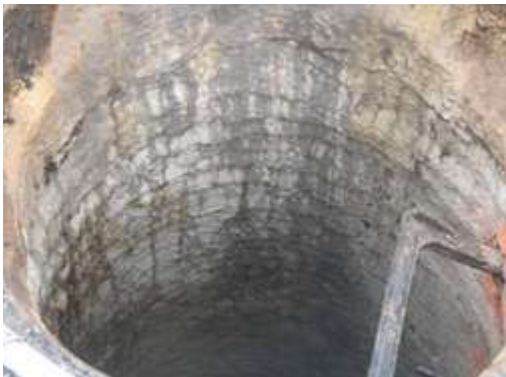
Defect

Infiltration: ☐ None ☒ **Joint** ☐ Cracks ☒ **Mortar** ☐ Roots ☐ Wall

Adjustment infiltration - other side.

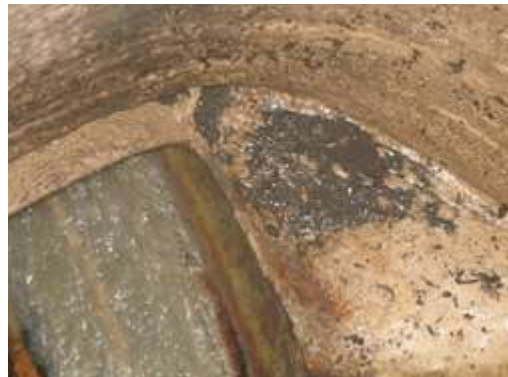
Defect

Infiltration: ☐ None ☐ Joint ☐ Cracks ☐ Mortar ☐ Roots ☒ **Wall**

Barrel infiltration.

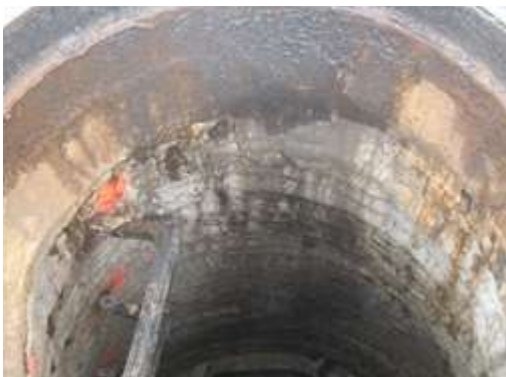
Defect

☒ **Leaks**

Condition: ☐ Sound ☐ Cracked ☐ Root Intrusion ☐ Loose Brick ☒ **Deteriorated**

Frame leaks. Adjustment deterioration and infiltration.

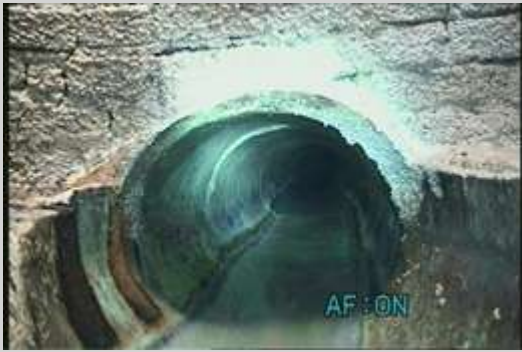
### 15 in. Circular Gravity Sewer

Condition: ☐ Sound ☐ Cracked ☐ Root Intrusion ☐ Loose Brick ☒ **Deteriorated**

Barrel deterioration.
